**Flood Control Project Maintenance
Levee Inspections**

Fall 2011 Levee Maintenance Deficiency Summary Report

Sacramento River Basin

**Flood Control Project Maintenance
Levee Inspections****LMA District Cover Sheet
Fall 2011 Levee Inspection Results****Reclamation District No. 2035 Conaway**

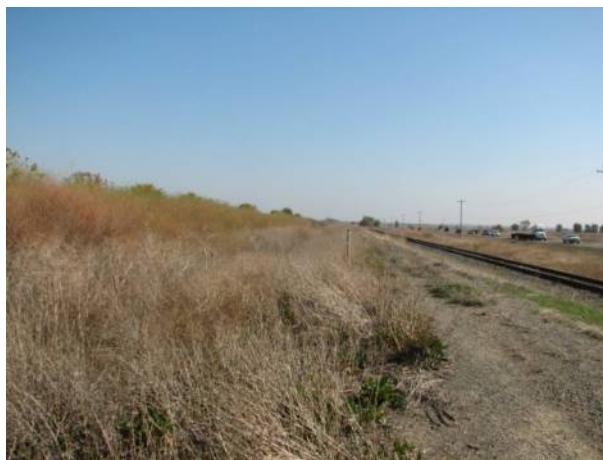
Levee Mile Report Line	2
Start Levee Mile	0.02
End Levee Mile	2.01
Location	Water Side
Category	Earthen Levee
Item	Vegetation

This photo shows the waterside vegetation at levee mile 0.00.

LMR No.	Levee Mile		Category	Item	Location *	Rating **	Action/Comment	GPS Latitude/Longitude		Issue No.
	Start	End						Start	End	Photo
1	0.02	0.57	Earthen Levee	Vegetation	CR	M	Remove the wild growth other than native grasses from the levee slopes.	38.677373 ° -121.709625 °	38.677331 ° -121.699334 °	3 Y
2	0.02	2.01	Earthen Levee	Vegetation	WS	M	Remove the wild growth other than native grasses from the levee slopes.	38.677373 ° -121.709624 °	38.677195 ° -121.673448 °	2 Y
3	0.02	2.01	Earthen Levee	Vegetation	LS	A	Remove the wild growth other than native grasses from the levee slopes.	38.677373 ° -121.709623 °	38.677192 ° -121.673459 °	1 Y

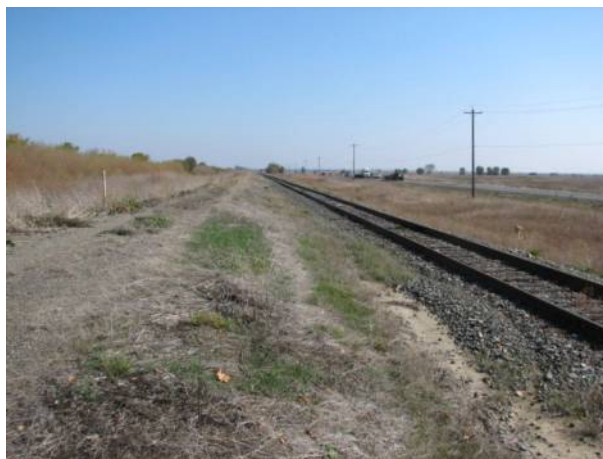
Levee Mile Report Line	3
Start Levee Mile	0.02
End Levee Mile	2.01
Location	Land Side
Category	Earthen Levee
Item	Vegetation

This photo shows the landside vegetation at levee mile 0.00.

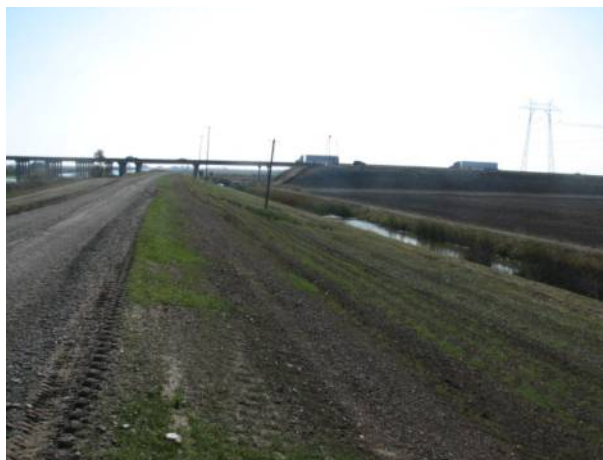
Levee Mile Report Line	1
Start Levee Mile	0.09
End Levee Mile	7.51
Location	Land Side
Category	Earthen Levee
Item	Vegetation

This photo shows the landside vegetation at levee mile 0.09.

Waterway						Bank	Unit Miles	Inspection Start/End	Inspector	
Unit No. 02 Yolo Bypass						Right	7.57	11/08/2011 11/08/2011	Clay Thomas	
LMR No.	Levee Mile		Category	Item	Location *	Rating **	Action/Comment	GPS Latitude/Longitude		Issue No.
	Start	End						Start	End	Photo
1	0.09	7.51	Earthen Levee	Vegetation	LS	A	Remove the wild growth other than native grasses from the levee slopes.	38.675927 ° -121.672367 °	38.575569 ° -121.634915 °	1 Y
2	0.09	7.51	Earthen Levee	Vegetation	WS	A	Remove the wild growth other than native grasses from the levee slopes.	38.675926 ° -121.672366 °	38.575568 ° -121.634915 °	2 Y
3	1.19	1.23	Supplemental	USACE Erosion Survey	WS	M	Inspector Comments: 2011: Small sections of slumping, likely from wind wave. [2011 Site ID: YOL_1-2_R]	38.660050 ° -121.669028 °	38.659465 ° -121.668940 °	4 Y
4	1.97	2.01	Supplemental	USACE Erosion Survey	WS	M	Inspector Comments: 2006 - Wave wash erosion and some saturation slumping occurring. Tension/separation cracks evident in fine grained levee slope materials. 2011: Small sections of slumping lower bank, just downstream of bank rock. [2011 Site ID: YOL_2-0_R]	38.648881 ° -121.666653 °	38.648178 ° -121.666385 °	5 Y

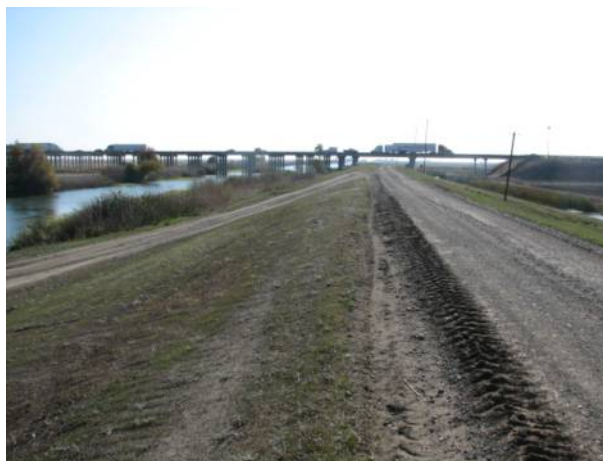
Levee Mile Report Line	2
Start Levee Mile	0.09
End Levee Mile	7.51
Location	Water Side
Category	Earthen Levee
Item	Vegetation

This photo shows the waterside vegetation at levee mile 0.09.

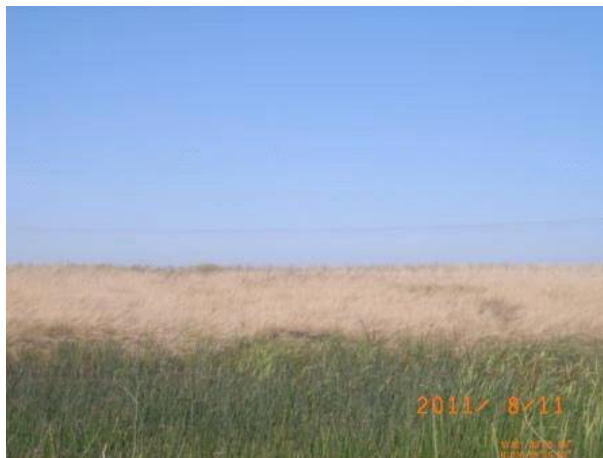
Levee Mile Report Line	3
Start Levee Mile	1.19
End Levee Mile	1.23
Location	Water Side
Category	Supplemental
Item	USACE Erosion Survey

USACE 2011 Photo #1

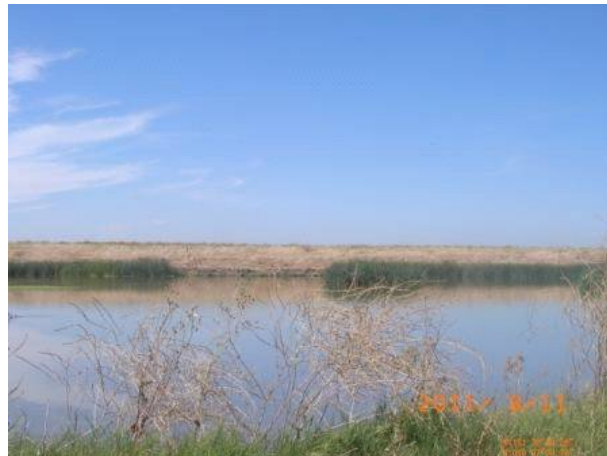
Levee Mile Report Line	6
Start Levee Mile	4.06
End Levee Mile	4.37
Location	Water Side
Category	Supplemental
Item	USACE Erosion Survey

5	2.23	4.01	Earthen Levee	Encroachments	LS	PO	Agricultural Ditch	38.645470 ° -121.665573 °	38.623062 ° -121.648925 °	979
6	4.06	4.37	Supplemental	USACE Erosion Survey	WS	M	Inspector Comments: 2006 - Wave wash erosion and some saturation slumping occurring. Several small scallops present in lower levee slope/toe due to saturation slumping. Tension/separation cracks evident in fine-grained levee slope materials. 2011: Small pockets of erosion throughout the site. Site formerly called 3.8. [2011 Site ID: YOL_4-2_R]	38.622224 ° -121.648201 °	38.618302 ° -121.645296 °	6 Y

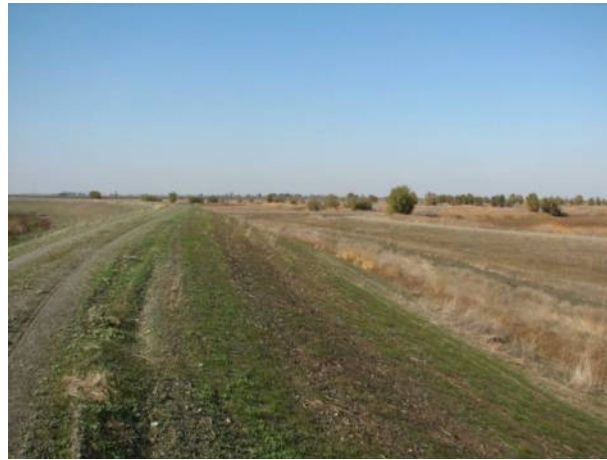
Levee Mile Report Line	1
Start Levee Mile	0.04
End Levee Mile	2.48
Location	Land Side
Category	Earthen Levee
Item	Vegetation

This photo shows the landside vegetation at levee mile 0.04.

LMR No.	Levee Mile		Category	Item	Location *	Rating **	Action/Comment	GPS Latitude/Longitude		Issue No.
	Start	End						Start	End	Photo
1	0.04	2.48	Earthen Levee	Vegetation	LS	A	Remove the wild growth other than native grasses from the levee slopes.	38.575460 ° -121.636394 °	38.590776 ° -121.664865 °	1 Y
2	0.04	2.48	Earthen Levee	Vegetation	WS	A	Remove the wild growth other than native grasses from the levee slopes.	38.575460 ° -121.636398 °	38.590777 ° -121.664865 °	2 Y
3	0.08	2.09	Earthen Levee	Encroachments	LS	PO	Agricultural Ditch	38.575615 ° -121.636680 °	38.590877 ° -121.657538 °	973
4	1.80	1.80	Earthen Levee	Crown Surface / Depressions / Rutting	CR	M	Add appropriate gravel or road base. Grade and compact.	38.591140 ° -121.652100 °	38.591140 ° -121.652100 °	5 Y

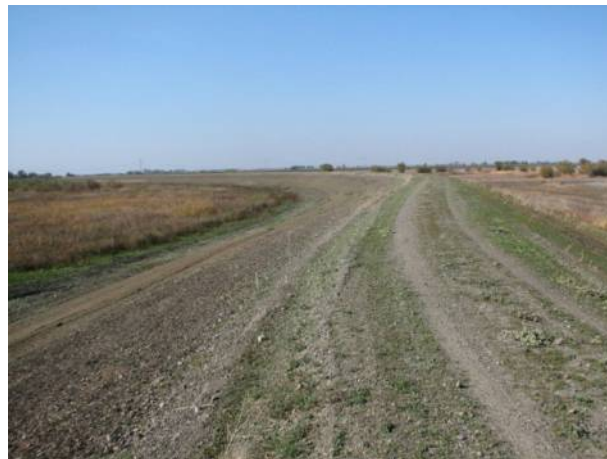
Levee Mile Report Line	2
Start Levee Mile	0.04
End Levee Mile	2.48
Location	Water Side
Category	Earthen Levee
Item	Vegetation

This photo shows the waterside vegetation at levee mile 0.04.

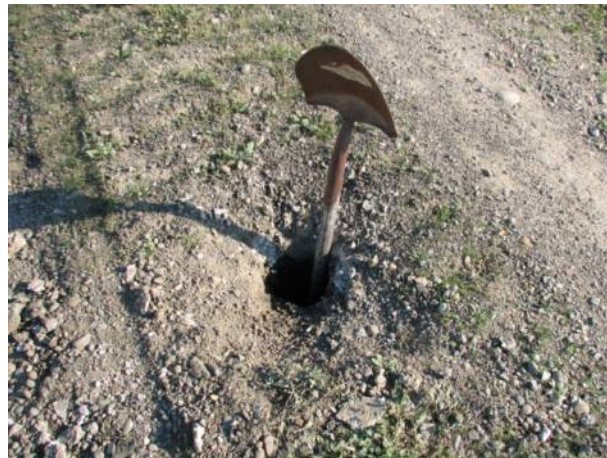
Levee Mile Report Line	4
Start Levee Mile	1.80
End Levee Mile	1.80
Location	Crown
Category	Earthen Levee
Item	Crown Surface / Depressions / Rutting

This appears to be a drill sampling hole, it appears to have been grouted and sank into the levee at levee mile 1.80.
